Henry Finch Memorial Fountain

Condition report

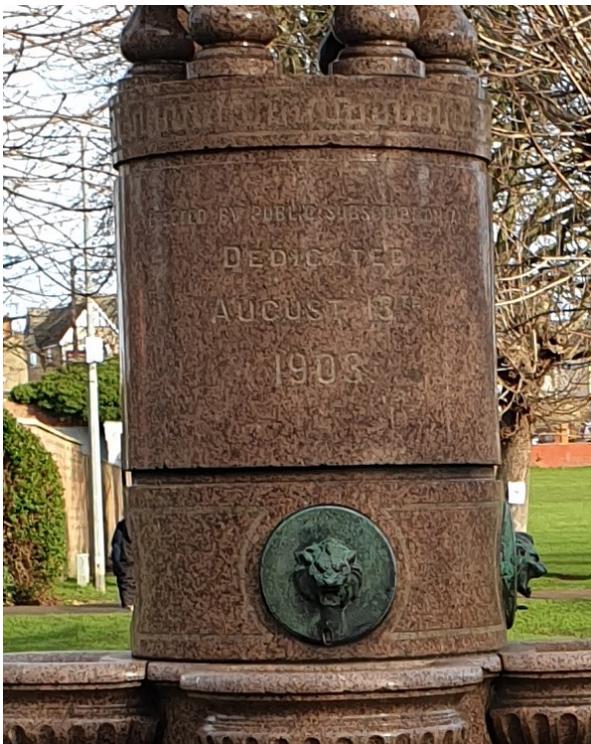
The carved inscriptions and decoration to the granite remain very sharp and distinctive. There are no signs of original highlighting i.e. gold leaf etc but this possibly could have been lost through years of weathering.

Image 1 shows the distinctive decoration , inscription and original lions

Further to the replacement of the missing lions head we would propose the following for the existing heads.

In the process of doff cleaning lightly agitate the verdigris with soft brushes ,this procedure should remove the surface patina. We would suggest consideration of light buffing in selected areas to re-introduce some shadowing in the patination. Following the work above being undertaken we would suggest treating with two coats of renaissance wax applied following pre warming of the bronze.

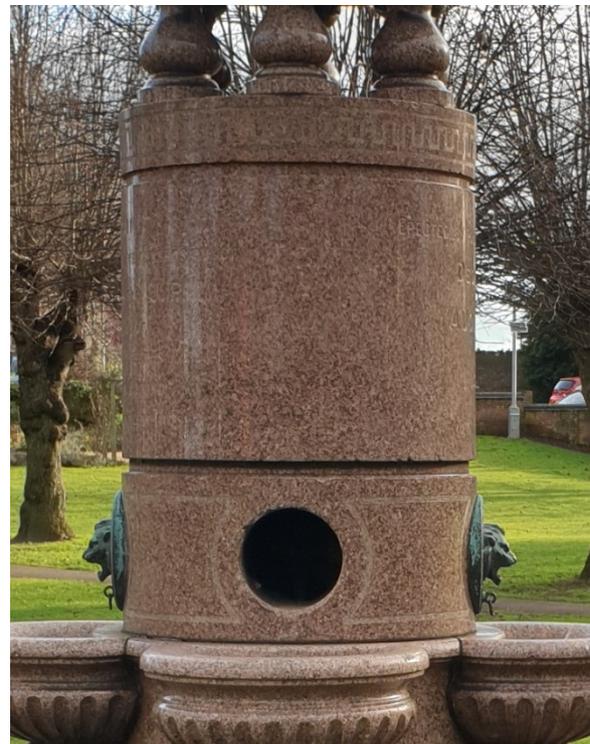
lions head.

head. Image 2 shows the missing

Lions head , scan existing lions head , produce pattern , cast bronze lions head and fitting = £5,110
